Processes of slope failure in crystallophyllian formations

Giraud, A., Rochet, L. and Antoine, P., 1990. Processes of slope failure in crystallophyllian formations. *Eng. Geol.*, 29: 241–253.

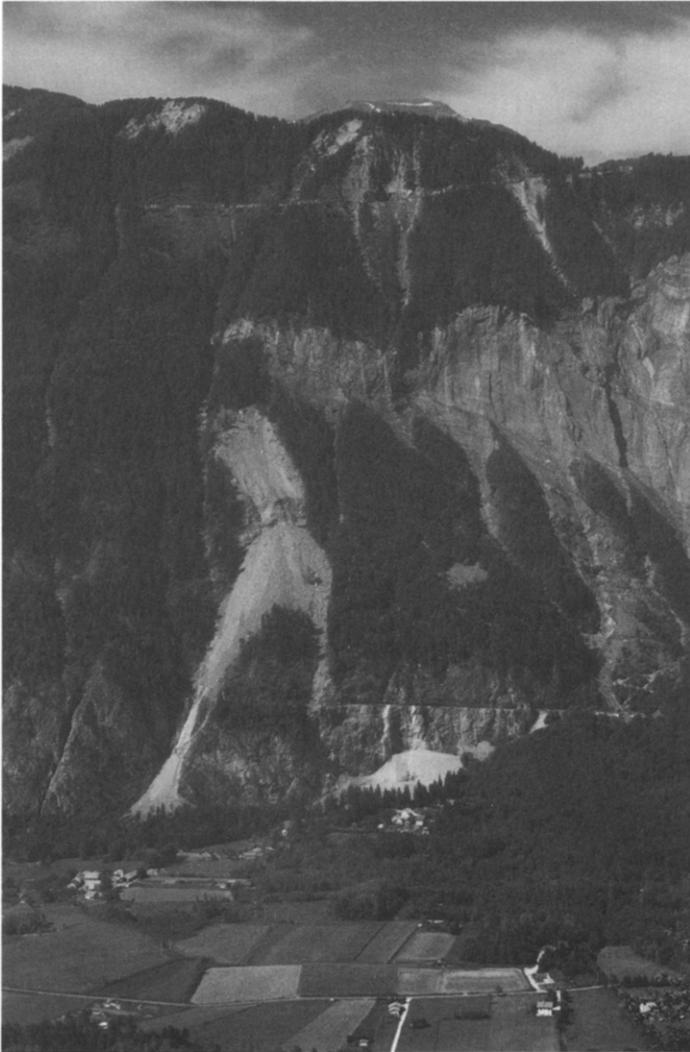
A landslide occurred at Charmonétier, near Bourg-d'Oisans in the Isère department of France, on 24 August 1987. Some 200 000 m³ of material were involved, reaching a maximum depth of 10 m (Fig.1).

The landslide occurred in migmatitic amphibolites with a natural slope of 35°–45° and foliation inclined at 25°–45° towards the valley. The foliation forms potential slip planes with a dip of the same order of magnitude as the angle of friction that might be expected in this type of material covering such areas.

Fig.1. View of the Charmonétier landslide.

Thus, in the case of the *Charmonétier landslide* mentioned above (p.241), the slip area was no more than 10 m thick.

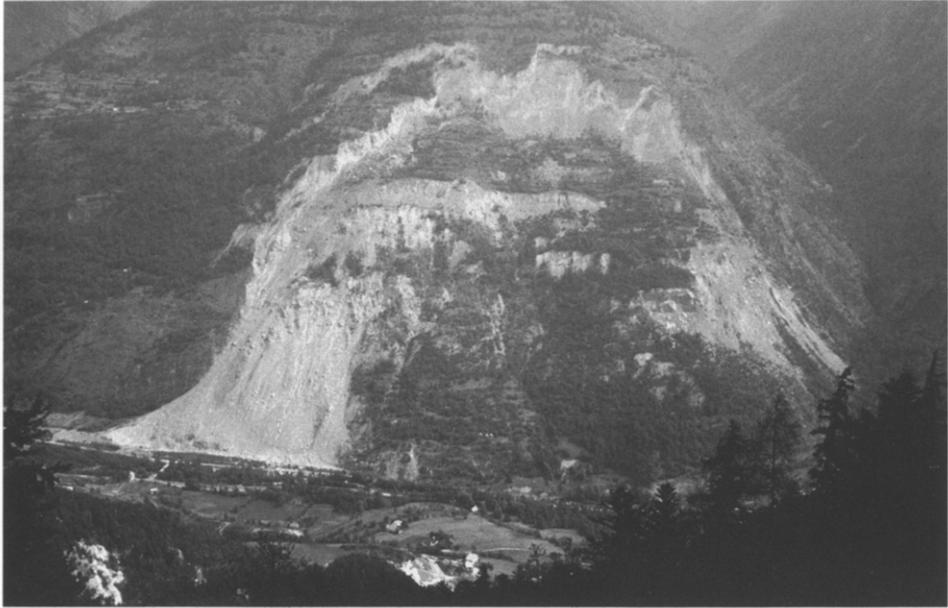
A similar structural context is found at the Clapière site (Blanc et al., 1987; Follacci, 1987) in a rock mass consisting of migmatitic gneiss with almost vertical foliation that has undergone widespread toppling over a distance of several hundred metres (Fig.3).

Fig.3. General view of La Clapière landslide.

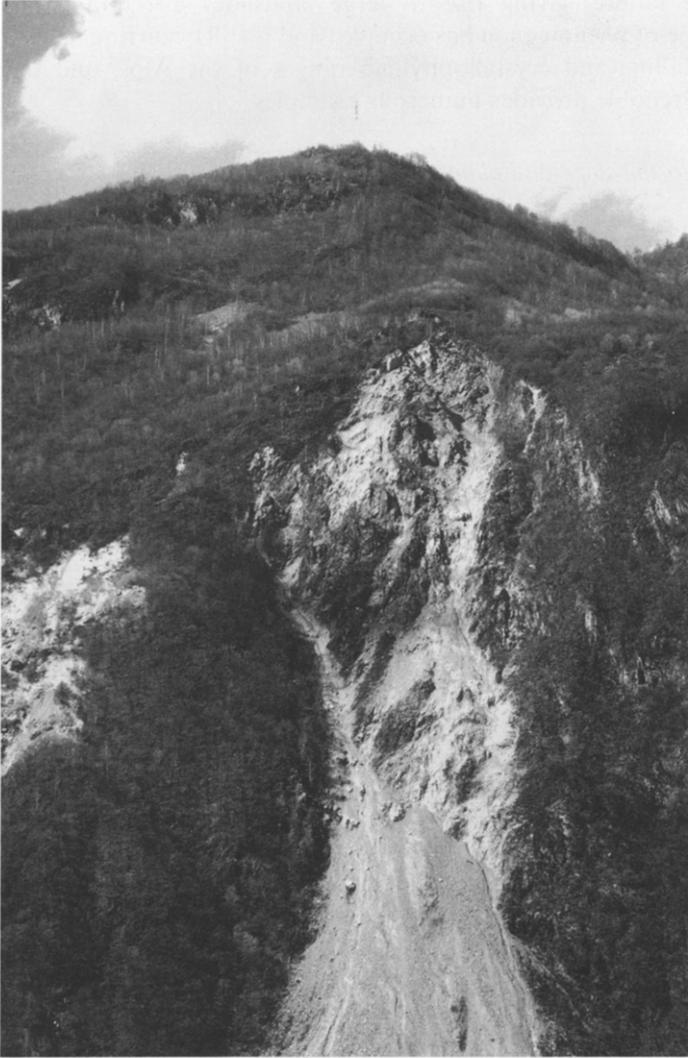
The middle section of the slope, where movement appears to have been greatest (involving an estimated 2–3 million cubic metres of rock), lies in the general area of instability running up to the summit of Mont Sec. It is therefore reasonable to assume that there is a risk of a massive landslide occurring, which could involve as much as 10–20 million cubic metres (Fig.5).

Fig.5. General view of the right bank of the Romanche valley at the Ruines de Séchilienne site.
