# The S chilienne Slope -Romanche Valley (ISERE), France

Jean-Louis Durville

Pierre Potherat

Rosalba Russo

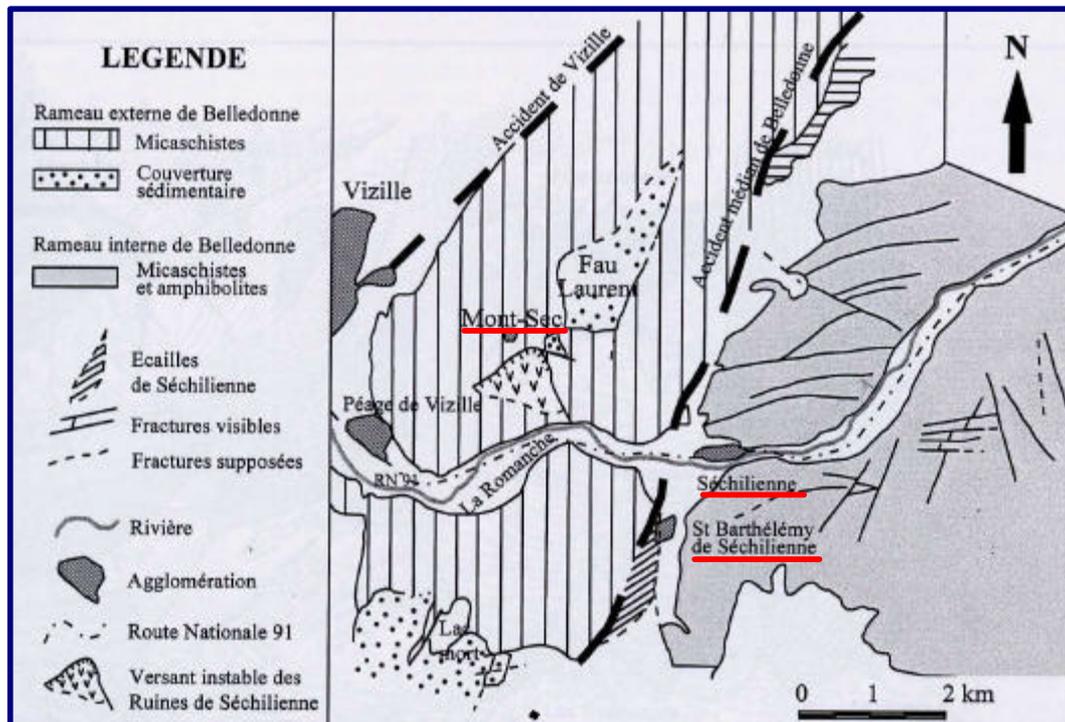
Fig. 2: Structural setting of the Belledonne mountain mass (after the Vizille geological map - 1:50.000).

The " Séchillienne Slope " site belongs to the old basement (ante-Westphalian) of the Belledonne chain, one of the external crystalline masses of the French Alps. That geological formation is articulated in two great units, external and internal branches, separated by the " synclinal median ".

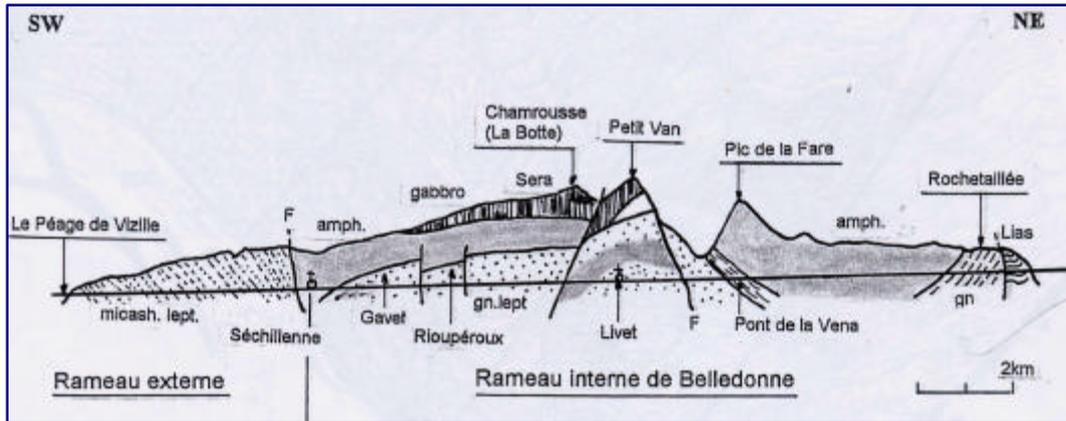
Fig. 3: E-W section of the Belledonne mountain mass along the Romanche valley between Vizille and Rochetaillée (after J.P. Menot)

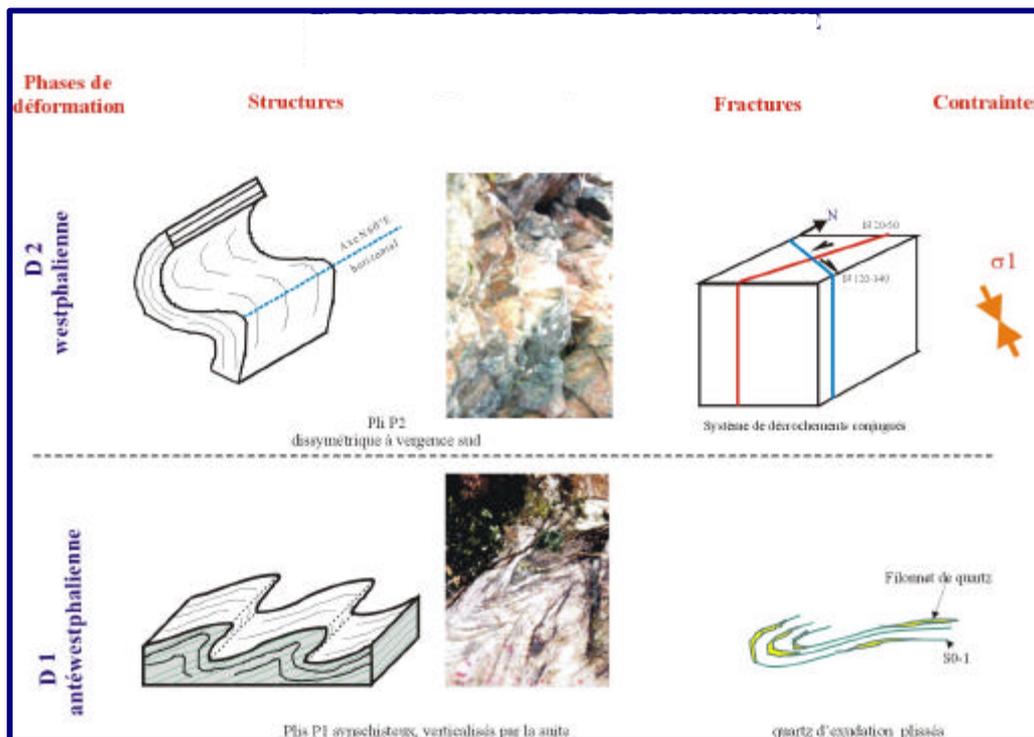
Fig. 4: The D1 and D2 structural stages

The hercynian stage ( of Westphalian age?) at the origin of the superimposition of the layers of the Belledonne complex causes the overlapping with southern vergency, of the basic Chamrousse basic formation upon the Taillefer unit and the genesis of P2 folds.

The P2 folds are asymmetrical ones with subhorizontal short side and subvertical long side, slightly dipping to the north (reverse side of a large fold with southern vergency?).

The horizontal axis has N.50 to N.80° E direction. We have observed these folds in Mont Sec subsidence but also at the entry of the mining gallery (level 900).

Some N60-70° E faults with a left lateral displacement are contemporary of that deformation stage.

These conjugated N20-50° E and N120-140° E faults have respectively left lateral and right lateral strike slips.

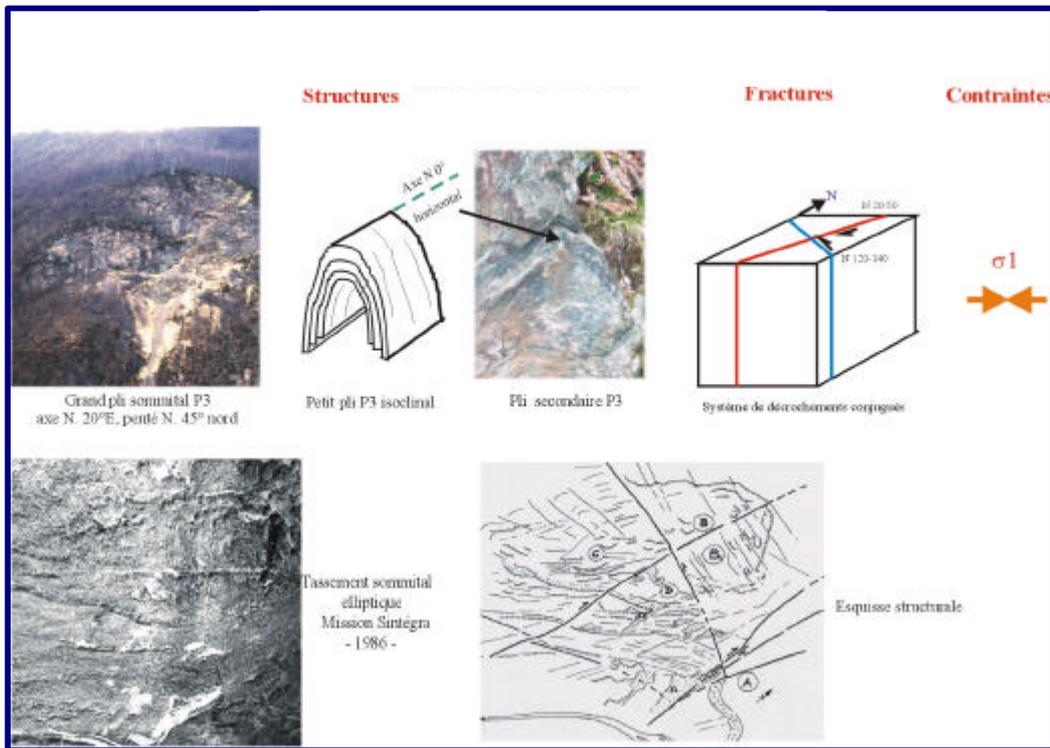
Fig. 5: The D3 structural stage

In the exploration gallery (level 900), a large fold was identified by structural measurements. That fold is also visible on oblique photographs taken from helicopter and constitutes the major structural feature of the Séchillienne slope.

The study of the foliation plans shows that all the upper part Mont Sec is affected by this broad fold.

Secondary P3 folds, with horizontal N.170° E to NS axis, affected again the P2 folds. Some of them are associated with reverse faults along accidents dipping to the west.

The N 20-50° E and N 120-140° E conjugated faults, moved into opposite direction of the previous lateral movement, therefore they have respectively a right and left lateral displacement. Two of them have a leading role in the division of the mass:

The N. 20° fault trending from the “Rivoirands” to the N-NE edge of the upper subsidence  
The N. 140° fault E forming the higher limit of the Ruins corridor.

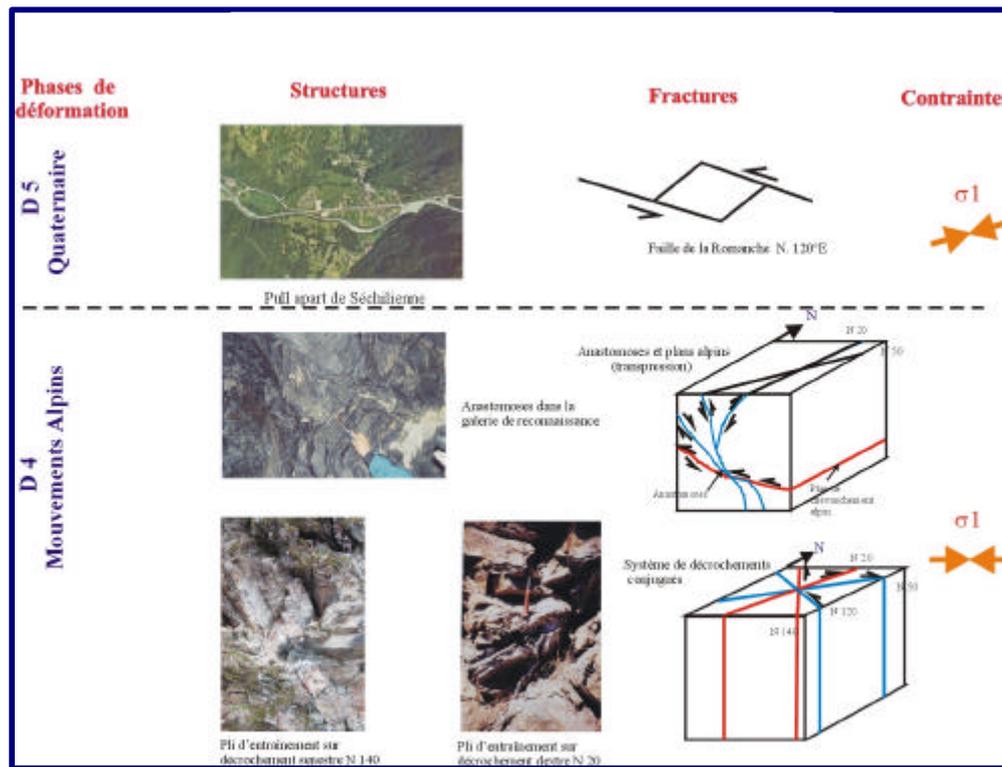
Fig. 6: The D4 and D5 structural stages

The P4 folds, with NS to N. 20-30° E axis dipping to the north, are present at several scales in the Séchilienne slope. Of metric size, they were observed in the higher part of the slope, in particular along the way which lead from the “Thiébauds” to the “Grand Combe” mine.

- N20° to N30°(K) faults more or less parallel to the synclinal median direction, which represents the overlapping of the Belledonne Internal branch upon the External one (Série Satinée). They are characterised by a right lateral strike slip (alpine age) which can be seen in the depression located south side of the Mount Sec (Grand Combe) to the passage of the main N20° fault across the Mont Sec subsidence.
- N 120° to N 140° (K') faults are conjugated with the previous ones. They are left right lateral strike slip faults (of alpine age), shown by the displacement towards the NW of the "Ruins" top and of the NE part of the subsidence summit. This movement is also apparent in the brutal interruption of the "Grande Combe", which appears to be displaced of approximately 80m towards the left.

The K fractures family is well expressed in the S-W side of the Mont Sec depression and in the slope, while the K' family, with a looser network, is visible in the northern side of the landslide.

- The fractures behind the Mont Sec (F) with a 40 meters high scarp, and a N.60°-E direction, are dipping 70° to the south;

- The "Grande Combe" (F'), is a ten meters deep graben, delimiting the upper elliptic depression to its southern side (N60-70°E direction, dip 65°N) ;
- The N60-70°E (F' ' -F' ' ') fractures dipping 65° to the north, form a dense network in the moving zone (« Ruins » corridor), where they are largely opened, under the double action of the Mount Sec releasing stress and the neotectonic. Many fractures of this type were located in the exploration gallery at the 710m level. The observed toppling shows their predominant action in the slope evolution.

The study of the cartographic documents and of the aerial photos of the Séchilienne sector, revealed in the Romanche valley, at the site of the Séchilienne village, the existence of a small losangic basin evoking a pull-apart type one.

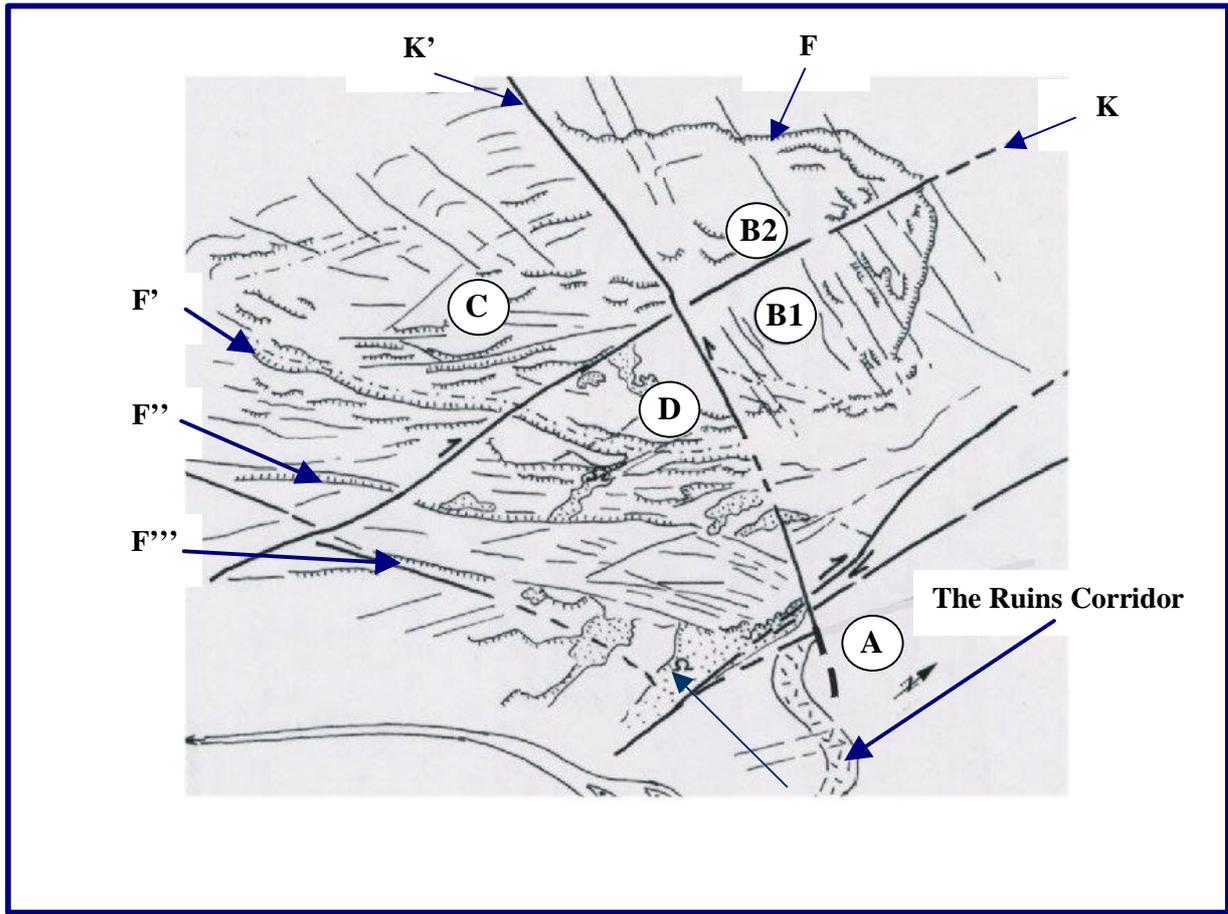
Fig. 7: Structural setting of the Séchilienne Slope  
(the surrounded letters show different moving areas).

Three important faults share the Séchilienne slope into four compartments differently structured.

**Compartment A:** to the east of the " Ruins " corridor the fractures are less dense and we don't find there the N70° in N80° directions;

**Compartment B:** (B1+B2): to the NE of the main N140° fault, this compartment is divided in to thin straps by accidents of comparable nature and direction;

**Compartment C:** the N20° and N70° discontinuities are better represented than N140° ones, almost absent;

**Compartment D:** delimited by the main N20° and N140° faults, the N20° and N70° accidents to N90° accidents are numerous whereas the accidents N 140° ones do not appear any more.

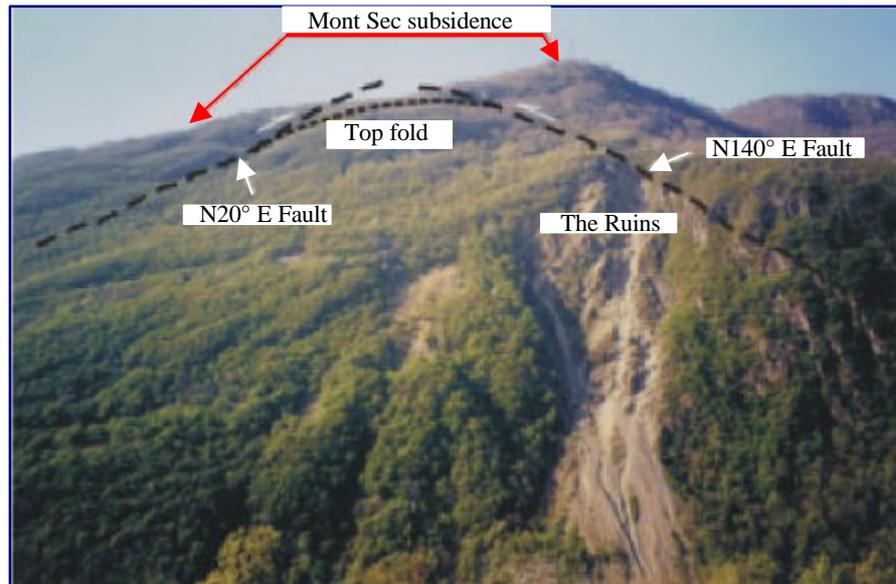
Fig. 8: View of the “Ruins” corridor and Mont Sec subsidence.

- ✓ The upper part of the Mont Sec area is characterised by the presence of an old subsidence due to an elliptic collapse, this zone being limited to the north by a 40m high scarp (F) and to the south by a few meters deep graben: the “Grande Combe” (F’).
- ✓ the slope is cut out by fractures with N60° - N70°E direction, (F’’ – F’’’), bordered by scarp facing to the north, which are similar to the “Grande Combe” graben.

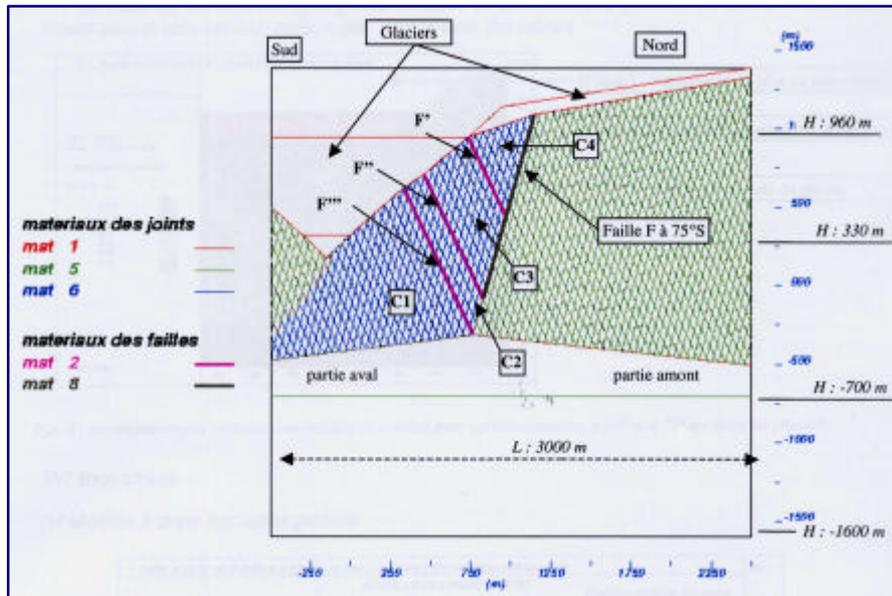
Fig. 9: Materials constitutive of the slope model with discontinuities F', F'' and F''' (65°N) and F (75°S)

Taking into account of the main systems of fractures (F, F', F'', F'''), it was possible to simulate the slope evolution due to glacier withdrawal, in comparison with the morphological observations (Fig. 9–10).

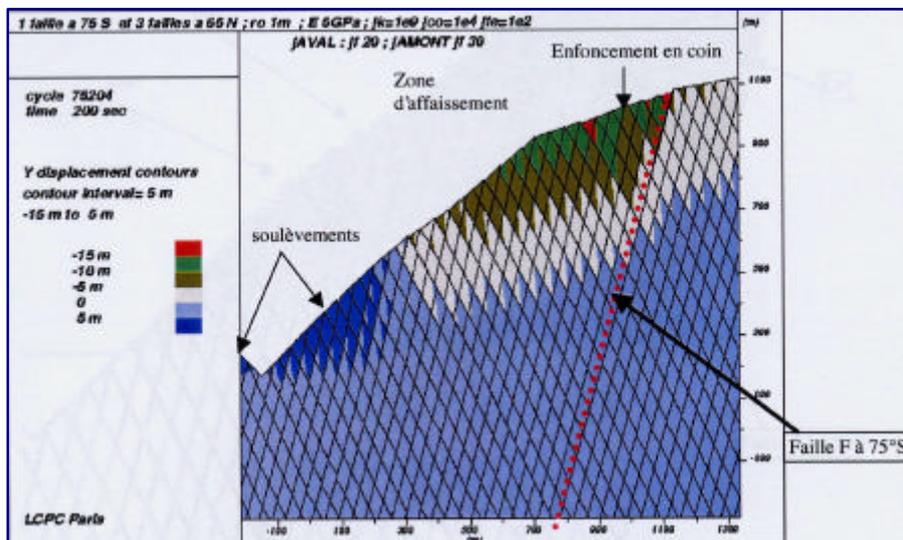
Fig. 10: Vertical displacement contours.

- 1) the opening of various families of discontinuities in the upper part of the landslide;
- 2) the delimitation of panels with variable kinematics;
- 3) the upper subsidence related to the wedge effect.

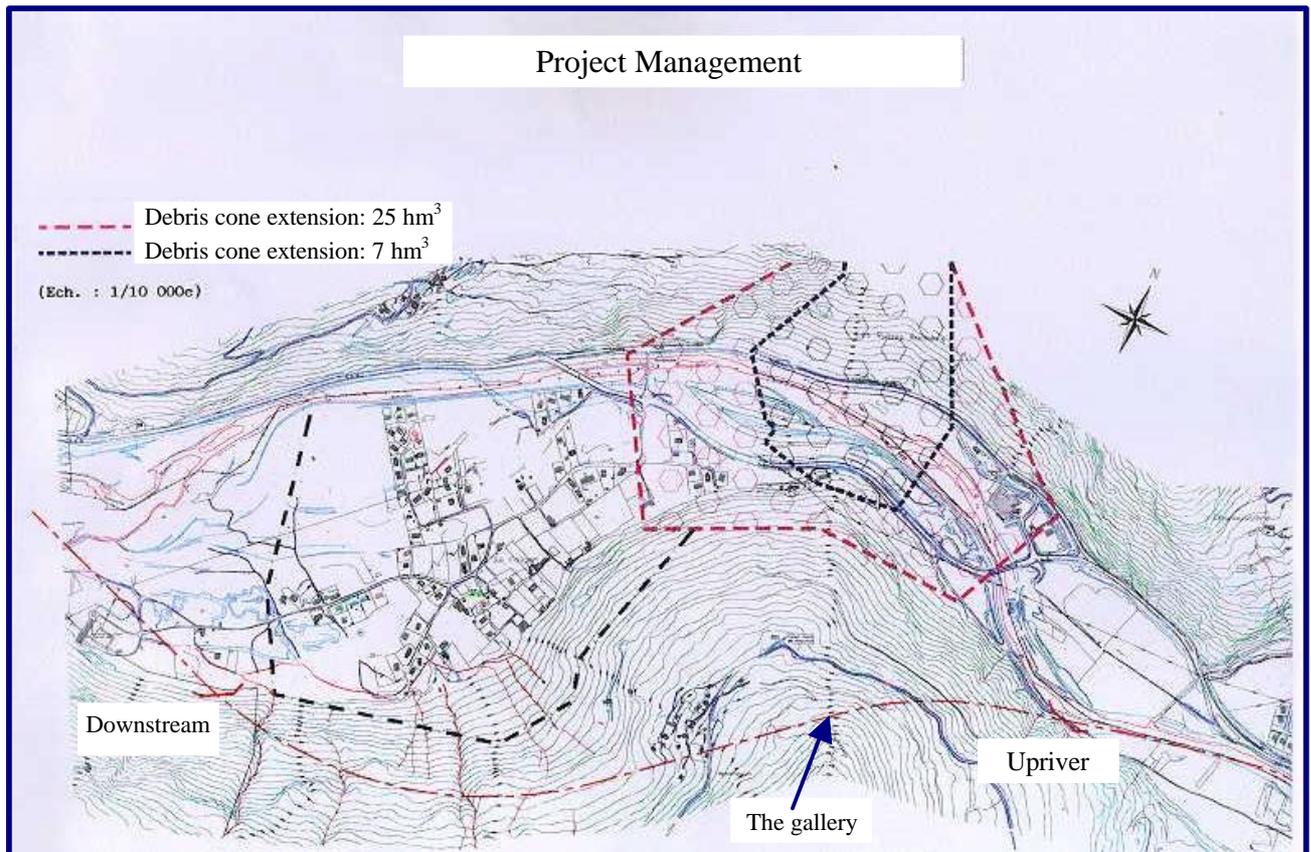
Fig. 12: Romanche underground derivation

This gallery has a length of 1934 m, and a diameter of approximately 15 meters and a slope of 1% . The foundation raft will be left gross, simply regulated for the passage of a 4x4 vehicle (Fig. 12).

- the gallery head is protected from the collapse, considered in its maximum extension, and from the effect caused from the air blast generated by the same event.

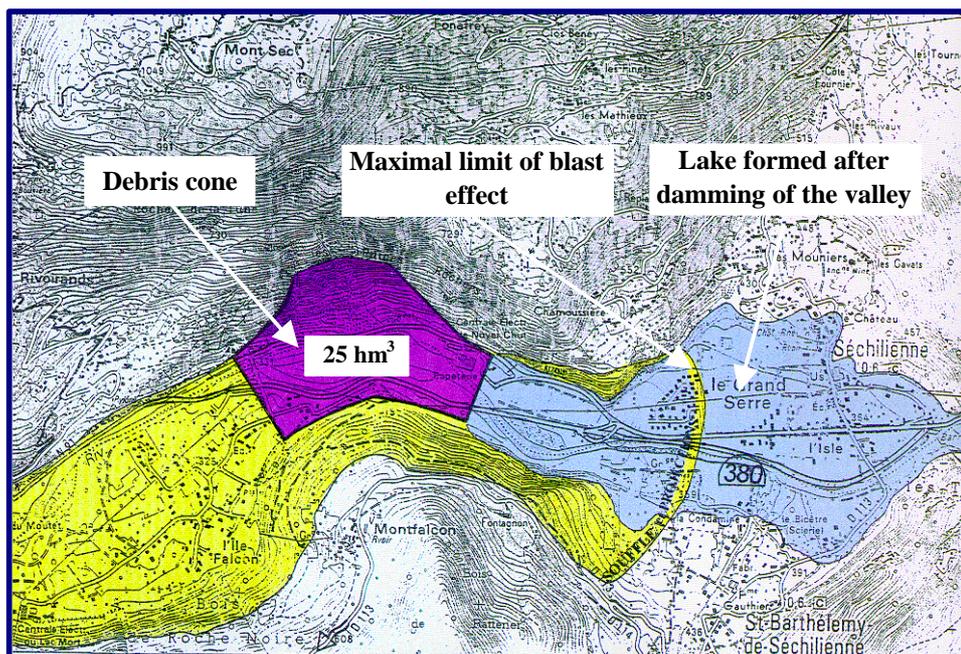
Fig. 14: Possible scenario after the landslide of 25 hm<sup>3</sup>

The possible rupture of the dam causes a water surge downstream to “Pont de Claix” with incalculable consequences on the whole of the residential areas and the industrial areas (chemical factories of Jarrie, Pont de Claix, etc...).
